TEST REPORT

NST/GW131661-2-S

Brass Cable Gland

M25 * 1.5

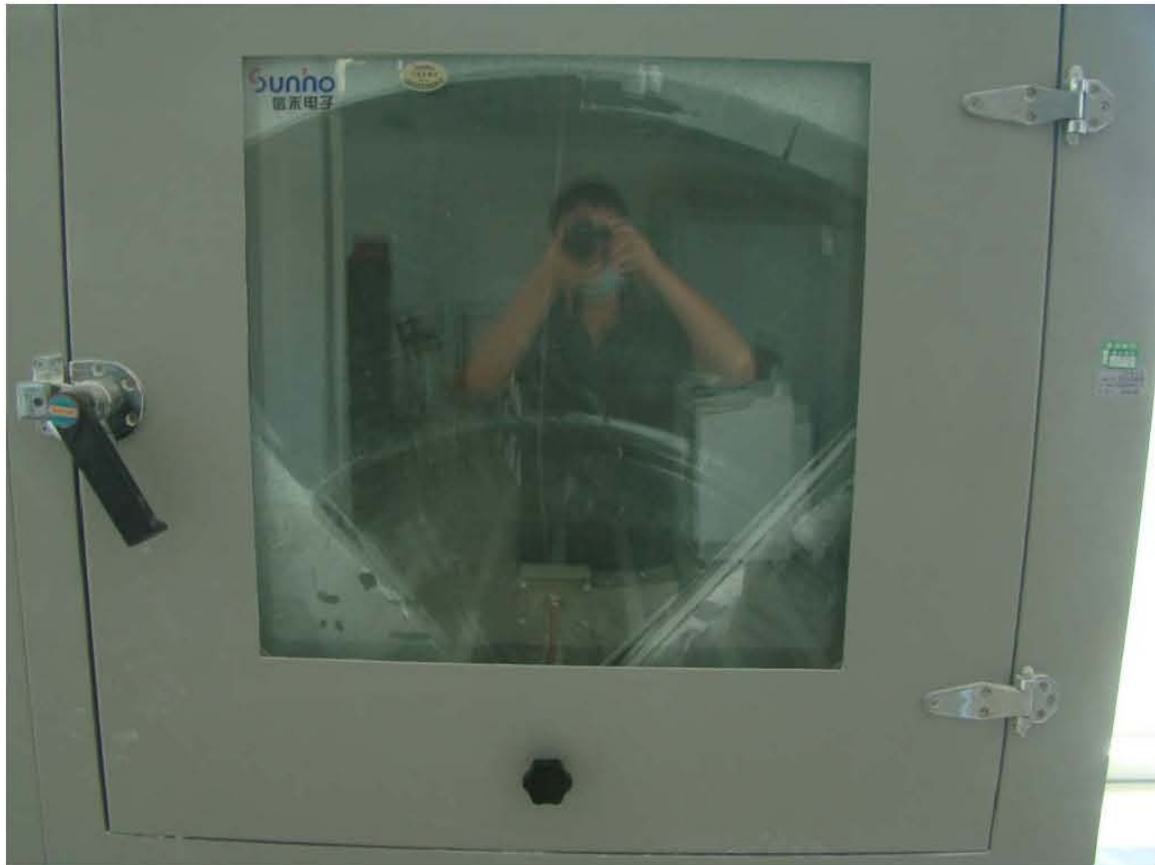
Photograph:

IP6X: The object is freely suspended in the dust chamber, lasted 8 hours with the depression not exceed 2KPa, the pressure inside the enclosure is maintained below the surrounding atmospheric pressure by a vacuum pump.

IP6X: No deposit of dust is observable inside the sample at the end of the test. So the protection is satisfactory.

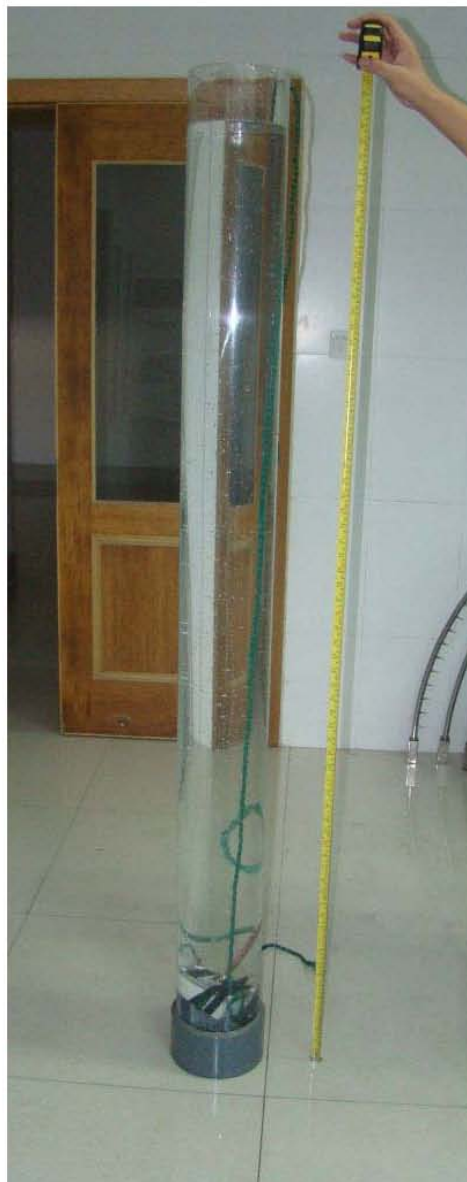
Operating conditions: IPX8: The lowest point of enclosures is located 1.5m below the surface of the water, the duration of the test is 35min; the water temperature does not differ from that of the equipment by more than 5K.

Phenomenon(after the test): IPX8: No water entered.

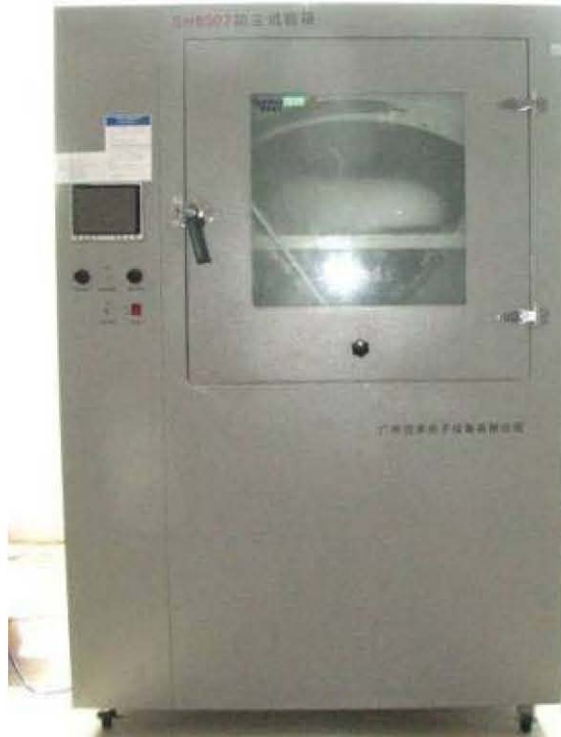
Fig.1 Dust chamber

- 1. Test equipments: Dust chamber (see Fig. 1), Immersiom test device(see Fig. 2),
- 2. Temperature: 22.5℃ Humidity: 70%RH
